Pavel Sergeyevich
Shcherban¹
Ekaterina
Vladimirovna Mazur

PRELIMINARY ASSESSMENT OF THE TECHNICAL CONSEQUENCES OF THE INCIDENTS ON THE NORD STREAM 1 AND 2 GAS PIPELINES. POSSIBLE WAYS OF SOLVING THE PROBLEMS

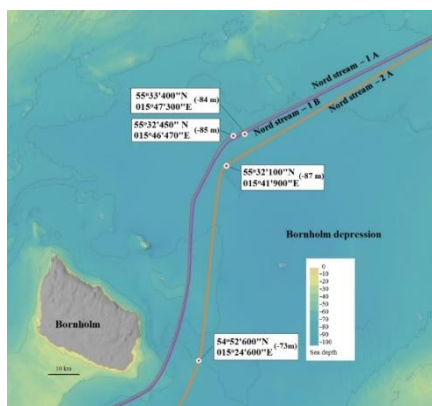
Let's consider the bathymetric characteristics of the position of the Nord Stream 1 and 2 pipes (Figures 2 - 4). The total thickness of the polymer coating is about 4.2 mm. The pipeline sections passing in the deepest areas are equipped with bend protectors, so-called deformation dampers, directly welded into the pipe and made of the same alloy, steel as the main pipes, but with a thicker wall and more delicate machining at the ends in order to match the main pipes. Let's consider the bathymetric characteristics of the position of the Nord Stream 1 and 2 pipes (Figures 2 - 4). Given the coordinates of the incident points, we can say that in the case of the North Stream 1 string A, the pipeline failure occurred at a depth of -85 m. In the case of string B, the pipeline rupture occurred at a depth of -84 m. In the case of Nord Stream 2 A, the pipeline breakdown occurred at a depth of -87 m and -73 m.

Figure 4. Breakdown points on gas pipelines and depths

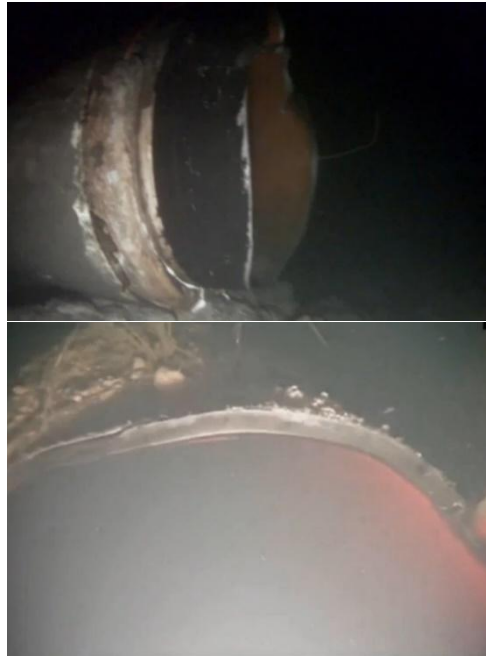
Figure 6. Destruction of the Nord Stream-1 pipeline section, initial inspection results

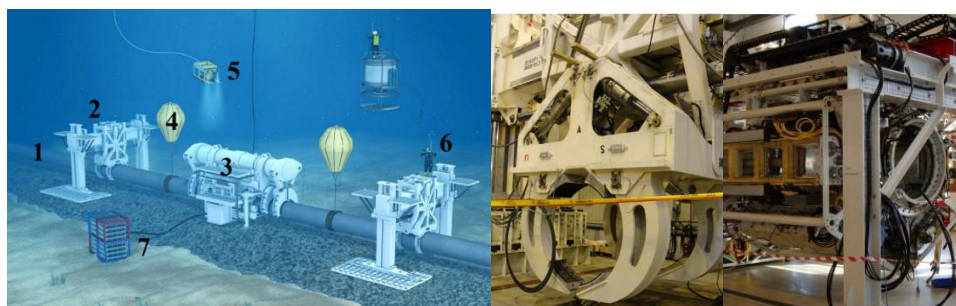
Figure 10. a - North stream pipeline bracing by hyperbaric welding; b - PHF; c - PRS.
 1 - Pipeline string; 2 - Supporting mechanisms (PHF); 3 - Hyperbaric welding chamber (PRS);
 4 - Inflatable diving lifting bag; 5 - Underwater inspection apparatus; 6 - Diver; 7 - Gas cylinders. Source: a- Nord Stream AG, b, c – Authors

In technological terms, the process is as follows. A specialized welding equipment is lowered on the sea floor, to the area containing the retained section, which has been cleaned and prepared by the divers; this is where the old section and the new section lowered from the ship can be welded (Amaechi et al., 2023).

The specialized dry-welding system used during construction of the Nord Stream pipelines was previously supplied by Statoil. It is a dry zone (PRS), where divers work without diving equipment to set up the automatic welding machine. At the same time, the welding process is fully controlled from the support vessel. At the same time, two specialized supporting mechanisms (PHFs) are lowered onto the same seabed

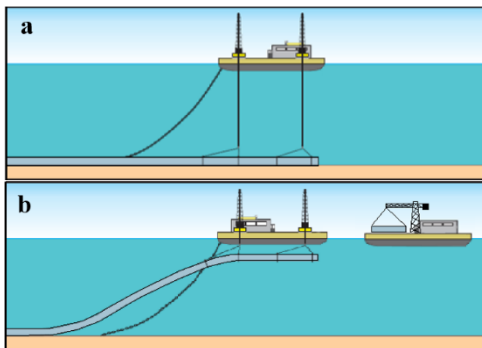
Figure 11. a. Lifting the flooded pipeline from the seabed; b. Bringing in additional pipes for welding on the surface

Another method of repairing damaged sections of gas pipelines is surface repair, using specialized vessels (Sharifi et al., 2022). Considering the process of welding area preparation, welding operations and subsequent flaw detection, as well as pipeline coating operations - this method allows to achieve higher quality and reliability and fully meets the requirements of DNV-OS-F101: Submarine Pipeline Systems. However, we should mention some specific aspects that may complicate this technological process. Initially, after inspection, clearing and elimination of the damaged pipeline section, cleaning and fastening of the repaired pipeline to the hoists is performed (Figure 11 a).

During this operation, the integrity of the lifted pipe string, the uniformity of fastening and distribution of loads during the lifting of the pipeline section are of great importance. Then, additional pipes are delivered to extend the pipeline (Figure 11 b).

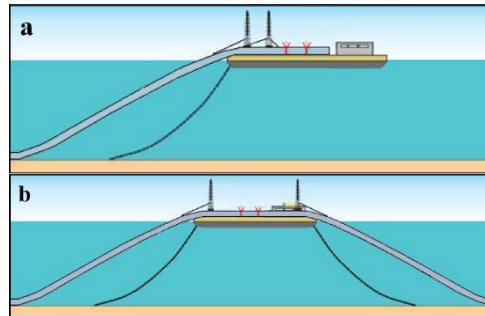
Figure 12. a. Emptying of the pipeline, inspection, preparation for welding, welding of new sections; b. Connection of the expanded section and the second end of the gas pipeline

At the same time the lifted pipe section is gradually filled with gas to be lifted aboard the ship. Next step is onboard inspection and inspection of the welded-on string, removal of protective coating on the end section, and subsequent onboard welding and joint assembling of the sections on the ship (Figure 12 a). This ensures their alignment,

At the final stage, welding is performed with the opposite old section, which is also lifted from the bottom, with the performance of the whole complex of measures for its examination and preparation for joining (Figure 12 b). After that, the final welding, weld quality control, coating with external protective coatings, lowering and laying on the bottom, with subsequent tests take place. In fact, this work was already performed during the construction of the Nord Stream pipeline, involving specialized vessels: Castoro Sei, Far Samson, Allseas' Solitaire, as well as many other tugs, supply vessels, and soil preparation vessels. Of course, arrangement of works using this technology will also require consolidation of efforts at the international level. At the moment, unfortunately, the Russian Federation doesn't have a fleet capable of handling the whole range of operations. However, there are plenty of contractors (as compared to underwater hyperbaric welding) in this case - a number of firms and companies in East Asia, South America and, of course, in Europe.
