## **PRELIMINARY ASSESSMENT OF THE TECHNICAL CONSEQUENCES OF THE INCIDENTS ON THE NORD STREAM 1 AND 2 GAS PIPELINES. POSSIBLE WAYS OF SOLVING THE PROBLEMS**

**Abstract:** *The incident on the Nord Stream pipeline system at the bottom of the Baltic Sea in 2022 caused a significant release of natural gas into the atmosphere and made it impossible to transport gas further through three of the four pipelines. Before the pipeline system was inspected and the results of the technical commission were available, a preliminary assessment of the volume of natural gas released was carried out, the possible technical consequences of the incident were evaluated and a preliminary assessment of the possibility of carrying out repair and restoration work was carried out. The existing technical solutions and alternative technologies to restore the pipeline system integrity have been analyzed. The feasibility of applying the technologies taking into account the specific conditions of the Baltic Sea has been evaluated. A preliminary assessment of the scope of repair works has been carried out and repair technologies have been considered.*

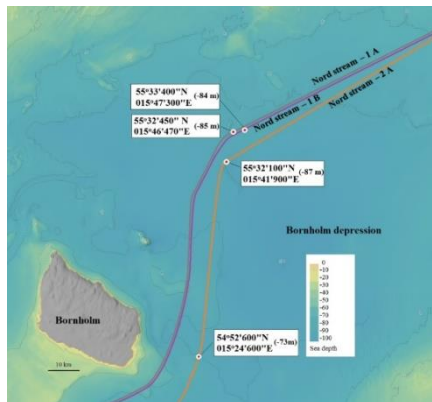
Let's consider the bathymetric characteristics of the position of the Nord Stream 1 and 2 pipes (Figures 2 - 4). The total thickness of the polymer coating is about 4.2 mm. The pipeline sections passing in the deepest areas are equipped with bend protectors, so-called deformation dampers, directly welded into the pipe and made of the same alloy, steel as the main pipes, but with a thicker wall and more delicate machining at the ends in order to match the main pipes. Let's consider the bathymetric characteristics of the position of the Nord Stream 1 and 2 pipes (Figures 2 - 4). Given the coordinates of the incident points, we can say that in the case of the North Stream 1 string A, the pipeline failure occurred at a depth of -85 m. In the case of string B, the pipeline rupture occurred at a depth of -84 m. In the case of Nord Stream 2 A, the pipeline breakdown occurred at a depth of -87 m and -73 m.

**Figure 4.** Breakdown points on gas pipelines and depths  
Source: Authors

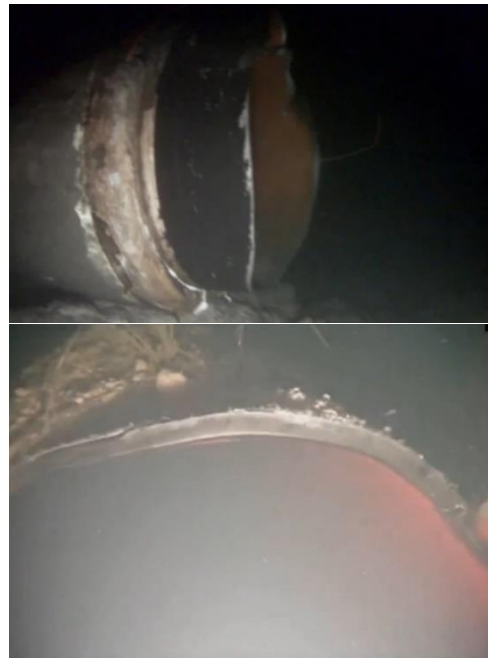
**Figure 6.** Destruction of the Nord Stream-1 pipeline section, initial inspection results  
Source: Nord Stream AG

Taking into account the complexity and high cost of repair and restoration of pipelines, it seems rational to repair only the Nord Stream-1A and B gas pipeline strings. In this case, the most affordable and at the same time controllable and qualitative way of repair will be lifting of flooded strings on a ship, its inspection, repair, extension, welding and lowering onto a prepared ground. To perform these works a wide range of contractors can be involved. It should also be noted that application of this technology will provide a full range of tests of the system after welding works in accordance with the requirements of DNV-RP-F113 Pipeline subsea repair.

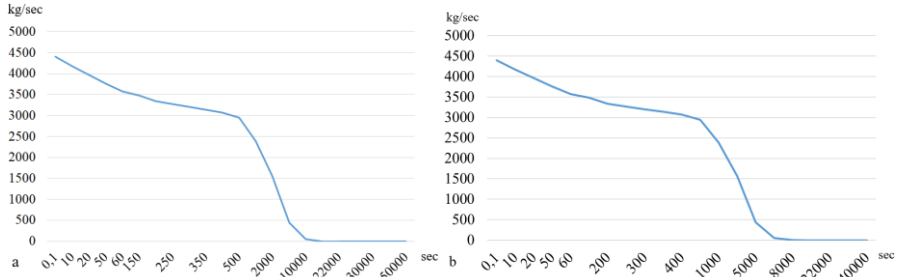
**Figure 7.** Graphs of natural gas leakages from the damaged segments of the Nord Stream 1A pipeline: a - section of the pipeline from the gas compressor station in Russia to the rupture place; b - section from the rupture place to Greifswald. Source: Authors

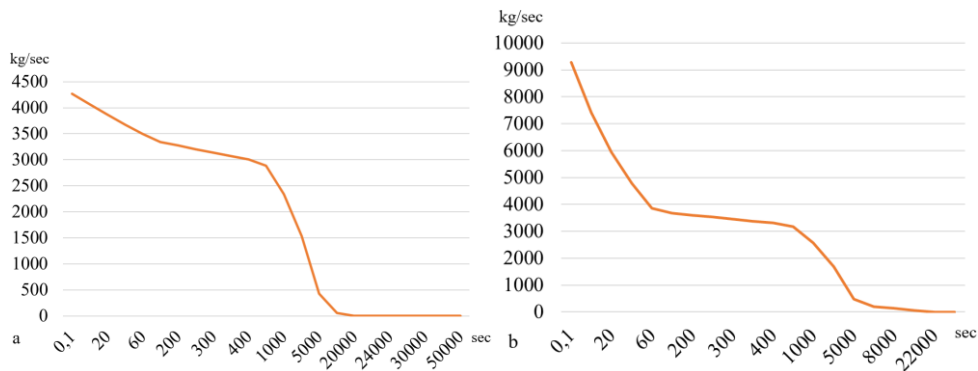
**Figure 8.** Graphs of natural gas leakages from the damaged pipeline segments of Nord Stream 1B: a - section of the pipeline from the gas compressor station in Russia to the rupture point; b - section from the rupture point to Greifswald). Source: Authors

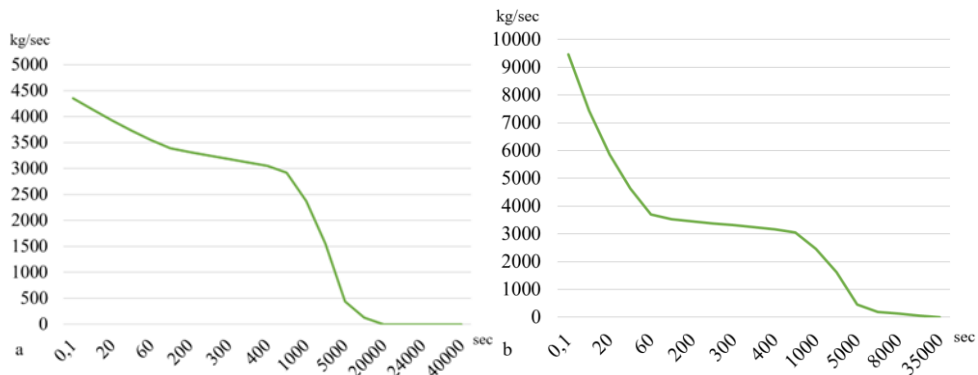
**Figure 9.** Diagrams of natural gas leakages from the damaged pipeline segments of Nord Stream-2A: a - section of the pipeline from the gas pumping station in Russia to the rupture point; b - section from the rupture point to Greifswald). Source: Authors
