**EXPERIMENTAL ANALYSIS AND
ISHIKAWA DIAGRAM FOR BURN ON
EFFECT ON MANGANESE SILICON ALLOY
MEDIUM CARBON STEEL SHAFT**

Abstract: Burn on/metal penetration is one of the surface defects of metal castings in general and steel castings in particular. A research on the effect of burn on the six ton medium carbon steel shaft for making a roller of cold rolled steel sheet produced at one of the metals industry was carried out. The shaft was cast using sand casting by pouring through riser/feeding head step by step (with time interval of pouring). As it was required to use foam casting method for better surface finish and dimensional accuracy of the cast, the pattern was prepared from polystyrene and embedded by silica sand. Physical observations, photographic analysis, visual inspection, measurement of depth of penetration and fish bone diagram were used as method of results analysis. The shaft produced has strongly affected by sand sintering (burn on/metal penetration). Many reasons may be the case for these defects, however analysis results showed that the use of poorly designed gating system led to turbulence flow, uncontrollable high temperature fused the silica sand and liquid poly

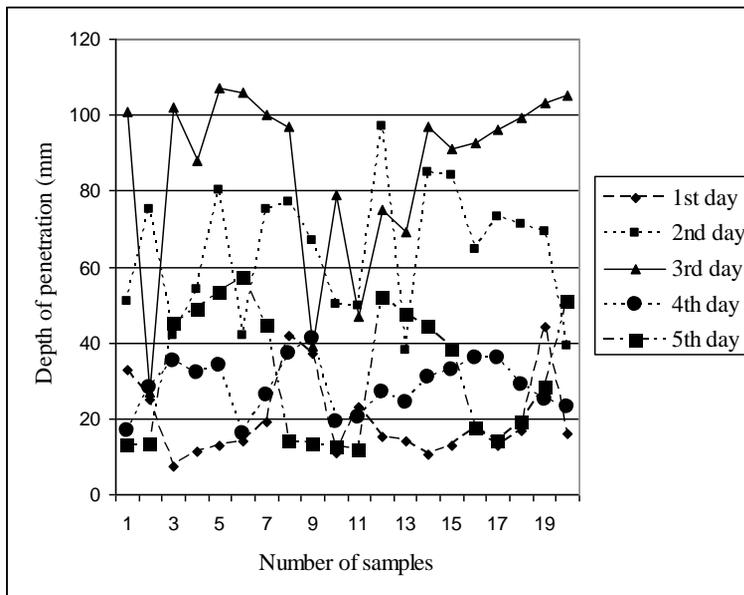
Figure 2. Depth of penetration (mm)

Figure 2 displays the depth of measured values of penetration. Depths of measurements were taken by part. The first part was the one, which the mold wall was coated by clay coating. There the detachment was less relatively, while the second day measurements took place on partially coated mold and partially uncoated mold part, thus the detachment increased on the uncoated part. The third day measurement was taken on the part where the second pour was made and where there was no polystyrene pattern. The fourth and fifth measurements were taken on the parts where partial polystyrene pattern was used and mold was also coated with clay coatings. Thus relatively small penetrations were observed. From the Figure 2 it is obvious that the 3rd day measurement values are higher than the other days, which confirms the maximum sand detachment from the mold on the uncoated mold wall as well as on the second pouring part of the mold where the second melt pouring caused turbulence and consequently erosion of mold. Since the sand particle detachment from the mold is high and the liquid metal is too hot due to the newly poured metal, liquid metal penetration is high and forms strong glassy penetration. It is clear that when there is liquid metal penetration, sand adhering to the solidified metal is strong and sand could not be removed easily and completely by grinding confirmed the formation of mechanical type burn on. It was thus important to analyze the causes of such defects (Appendix 1). The type of sand used for mold making as mentioned above was silica sand bonded with furan resin. Moreover it was repeatedly used and reclaimed, where possibly iron oxide that is plastic in nature and piled up at higher temperature due to its low refractoriness was included and reduced the quality of silica sand in that when it is pure its fusing temperature is high as a result of which mold material erosion is reduced. More over the iron oxide may be reduced to iron and cause fusing and sticking. The temperature control mechanism used was worked poorly, as a

result of which the melting temperature of the mentioned steel reached above 1700°C (as informed from the operator of the furnace). In contrary the refractoriness of silica sand reaches maximum up to 1580°C (as per the information from the industry) and starts to collapse above this temperature. In this regard the silica sand was fused and reacted with liquid metal resulting in burn on. Due to the higher temperature the binder was evaporated at earlier time and form steam that reacted with the liquid metal at the same time molding sand was eroded and the detached sand particles penetrated the metal mixed within the molten metal distributing into many parts of the cast shaft.

This may be due to turbulence effect. In the molding process no test on sand distribution, shape of sand grain and size was carried out. It is clear that shape, and size (fineness) have a negative effect on bonding strength and permeability. The shape and size determine the distribution of sand and in turn the bond strength is directly or indirectly explained by mold wash (erosion). Most of the time the coarse grain sand is used for large size castings, however in the casting process of the shaft this condition was not considered. The phenomena were confirmed from the physical observation after solidification and grinding the cast.

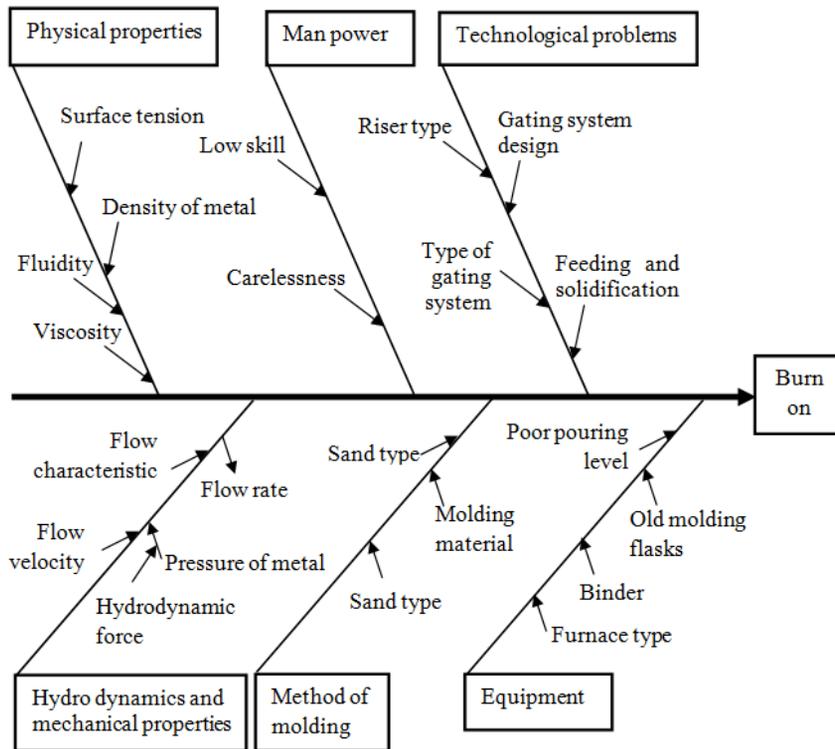
Figure 3. Cause and effect diagram of burn on

As discussed earlier various causes are mentioned as sources of burn in/burn on casting defect. When the causes are complicated, the cause and effect diagram displayed in Figure 3 helps to analyze the root causes and suggest remedial remarks. Based on this the causes are analyzed (Figure 3) in detail. Comparing to part of the shaft, where polystyrene was removed and un-removed more burn on/metal penetration was formed on the shaft part, where polystyrene was removed. In the un-removed part polystyrene gas and melt reacted with metal and sand that form burn on, which was assumed to be thermal type; in the removed case, the uncoated mold was exposed to high temperature and metal flow was turbulence that caused erosion of the mold and mechanical sand adhering or metal penetration was the result. As the pouring ladle was teapot type the possibility of drosses, slagging and similar inclusions could also facilitate burn on effect.

Accordingly, other than the temperature effect, which is commonly known the physical and mechanical as well as technological factors caused burn on/metal penetration (Figure 3). Figure 3 shows cause-and-effect/Ishikawa diagram of burn on/metal penetration on steel shaft (Ishikawa, 1990).

As explained above the metal was over heated and thus fluidity of the metal increased as a result of which viscosity and surface tension also decreased, consequently the flow velocity increased and the flow characteristics was tend to be turbulent being cause of mold erosion, disturbance of liquid metal and raised inclusion reaction. The condition may also lead to mold material friability and consequently burn on.

As mentioned earlier, the shaft was cast using the feeding head as gating system. The shape of the feeding head was cylindrical and was used as a top gating system. The size of the feeding head was not adequate to hold the required amount of hot metal to pour in to the mold and filled as required. These conditions also worsen the problem that deep metal penetration and unfilled part of the cast as well as in-homogeneity of structure were the results. In this regard designing appropriate gating system and riser could alleviate the problem of metal penetration.

Since the cylindrical shaped riser was used as a gating system and the diameter of stream was almost equivalent to the diameter of the cylinder the flow was fully stream type with higher turbulence, where Reynaldo's number may be higher than 3000 (industrial experience for steel) and thus led to again erosion of the mold and disturbance of the liquid metal, where metal-mold material reactions significantly increased as a result of which burn on/metal penetration was developed.

The manual mold process carried out particularly for this shaft cause soft rammed mold and an equal distribution of sand particles resulted in burn on sand. Generally causes of metal penetration can be much more than the factors displayed in Figure 3.

Furnace replacement with large capacity, provision of temperature controlling devices, proper gating system design together with dry sand molding without foam pattern, but by coating proper refractory materials may improve the condition of sand burn on steel castings of various categories in the mentioned industry.

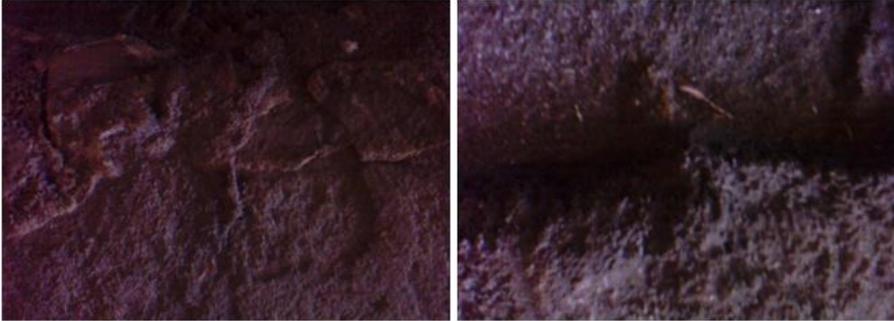
As seen in Appendix 1, sand has adhered on the surface of the shaft strongly in large quantity. From Appendix 1(a) it is clear that the mold material was totally eroded and there was inherent friability of the sand. The adhered sand was not removed by simple shaking (b) and was necessary to use hammering (c). From the observation hammering of the adhered sand took about 6 hrs.

a) Immediately after breaking the mold b) After shaking out

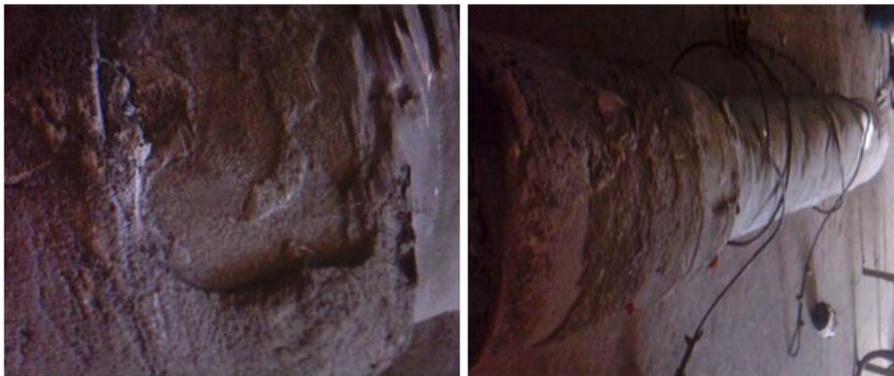
Grinding of the surface was made step by step (d, e). After grinding the surface (f) the final result obtained was not free of metal penetration. As the shaft was newly designed and cast product and as there are no other bench marks or standards to compare the obtained result, it was necessary to measure the depths of penetration and determine the level of the quality of the cast. Hence, after final grinding of the shaft measurements of sand penetration were carried out using Vernier caliper mentioned in the method above. About 100 points, with the major damage was measured in 5 days 20 measurements per day and the results are displayed in Appendix 2. Not only surface defects but also a sub surface defect of up to 107mm depth was observed, where in some specific areas even the diameter reduces to up to 133mm. As seen in the table, this is obvious in the 3rd day measurements. From the table it is possible to observe that the minimum depth of penetration is 11mm and the maximum depth of penetration is 107mm. These defects could not be removed even by machining since the shaft at this point is under sized. As shown in Appendix 1(f), the final diameter required was 240mm but after grinding the final diameter became 133mm minimum and 229mm maximum, which is below the standard.

b) After removal of sand by hammering d) After preliminary grinding with riser at the top

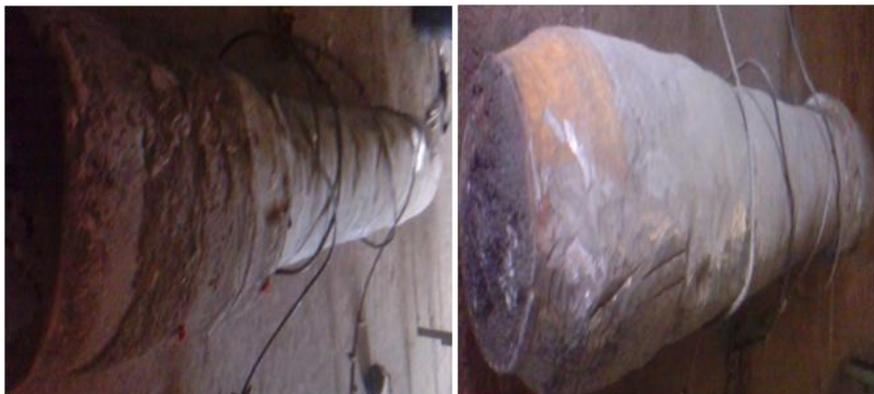
e) Continuation of sand removal by hammering f) Final product obtained
