Pavel Sergeyevich
Shcherban¹
Ekaterina
Vladimirovna Mazur

PRELIMINARY ASSESSMENT OF THE TECHNICAL CONSEQUENCES OF THE INCIDENTS ON THE NORD STREAM 1 AND 2 GAS PIPELINES. POSSIBLE WAYS OF SOLVING THE PROBLEMS

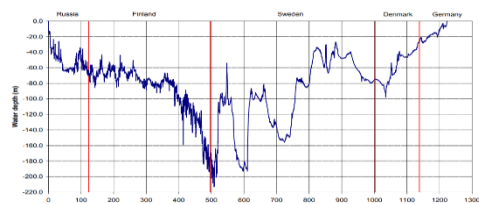
Figure 2. Depth of Nord Stream 1A and 1B.
Source: North Stream AG

Let's consider the bathymetric characteristics of the position of the Nord Stream 1 and 2 pipes (Figures 2 - 4). The total thickness of the polymer coating is about 4.2 mm. The pipeline sections passing in the deepest areas are equipped with bend protectors, so-called deformation dampers, directly welded into the pipe and made of the same alloy, steel as the main pipes, but with a thicker wall and more delicate machining at the ends in order to match the main pipes. Let's consider the bathymetric characteristics of the position of the Nord Stream 1 and 2 pipes (Figures 2 - 4). Given the coordinates of the incident points, we can say that in the case of the North Stream 1 string A, the pipeline failure occurred at a depth of -85 m. In the case of string B, the pipeline rupture occurred at a depth of -84 m. In the case of Nord Stream 2 A, the pipeline breakdown occurred at a depth of -87 m and -73 m.

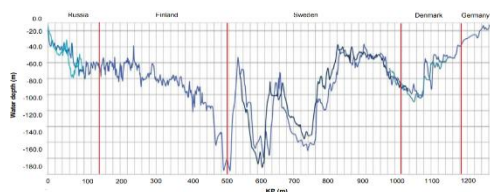
Figure 3. Depth of Nord Stream 2A.

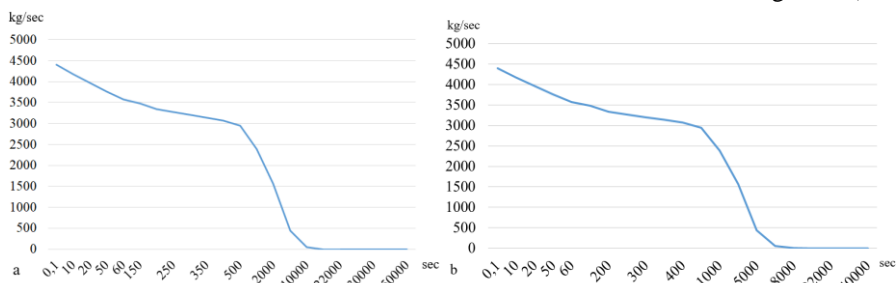
For the second cutoff section, we perform the same calculation. The intensity of gas outflow in each of the strings during the incidents on the North Stream 1 and 2 are shown in the graphs (Figures 7 - 9). We assume that the time passed from the moment of the incident to the moment of complete closure of the line valves at both sections of the pipeline is 40 sec. For the second section of length x_2 the calculations are made in the same way (Lurie et al., 2020).

Figure 7. Graphs of natural gas leakages from the damaged segments of the Nord Stream 1A pipeline: a - section of the pipeline from the gas compressor station in Russia to the rupture place; b - section from the rupture place to Greifswald. Source: Authors

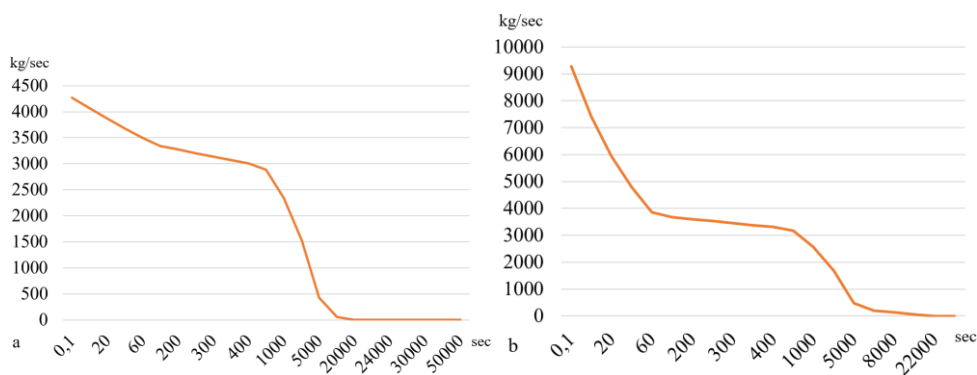
Figure 8. Graphs of natural gas leakages from the damaged pipeline segments of Nord Stream 1B: a - section of the pipeline from the gas compressor station in Russia to the rupture point; b - section from the rupture point to Greifswald). Source: Authors

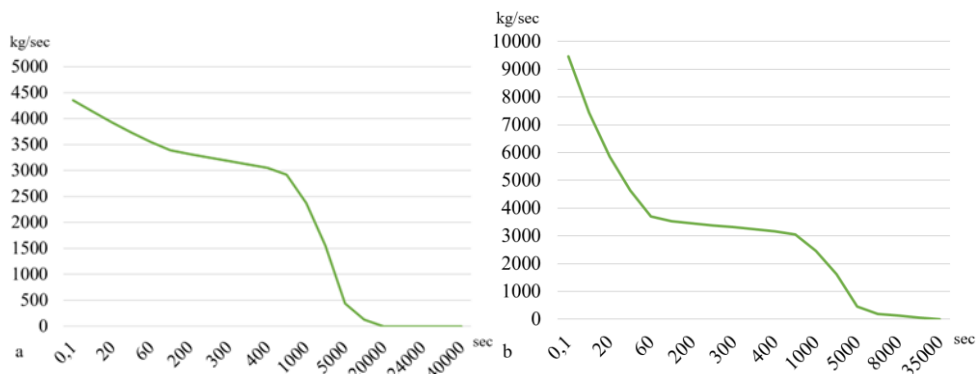
Figure 9. Diagrams of natural gas leakages from the damaged pipeline segments of Nord Stream-2A: a - section of the pipeline from the gas pumping station in Russia to the rupture point; b - section from the rupture point to Greifswald). Source: Authors
